**EVALUATION OF THE EFFECTS OF A PLASTIC BEAD  
PAINT REMOVAL PROCESS ON PROPERTIES OF  
AIRCRAFT STRUCTURAL MATERIALS**

Materials Integrity Branch  
Systems Support Division

December 1985

Final Report for Period October 1984 to August 1985.

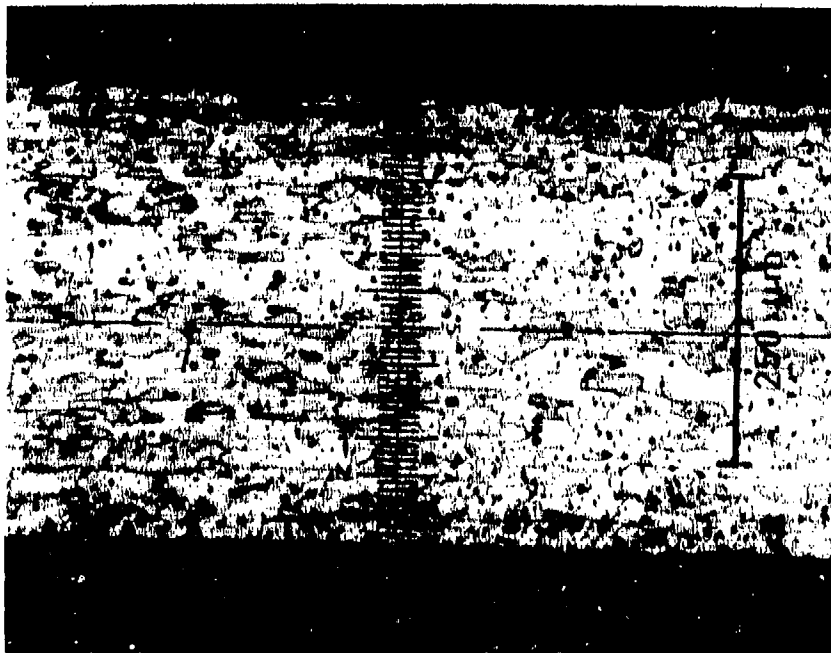
Figure 12. Alclad 7075-T6 After the Third Paint Removal. (a) Specimen 24B, 38 psi nozzle pressure (b) 60 psi nozzle pressure. MAG: 160X

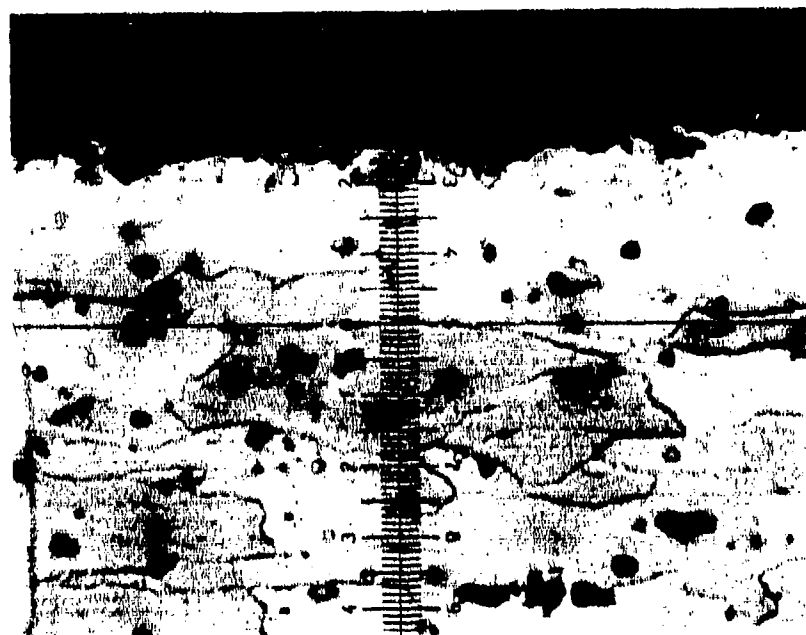
The features found in this portion of the program were similar to those found in the previous section. The cladding was damaged and exhibited pitting, thinning and cracking just as in the sequential paint removal operations described previously. Figures 14 and 15 typify the effects of plastic bead removal of five coats of paint in one operation.

Figure 15. Alclad 7075-T6 Thin Skin Honeycomb with Five Coats of Paint After One Paint Removal at 60 psi (Specimen 52B). MAG: (a) 160X, (b) 800X

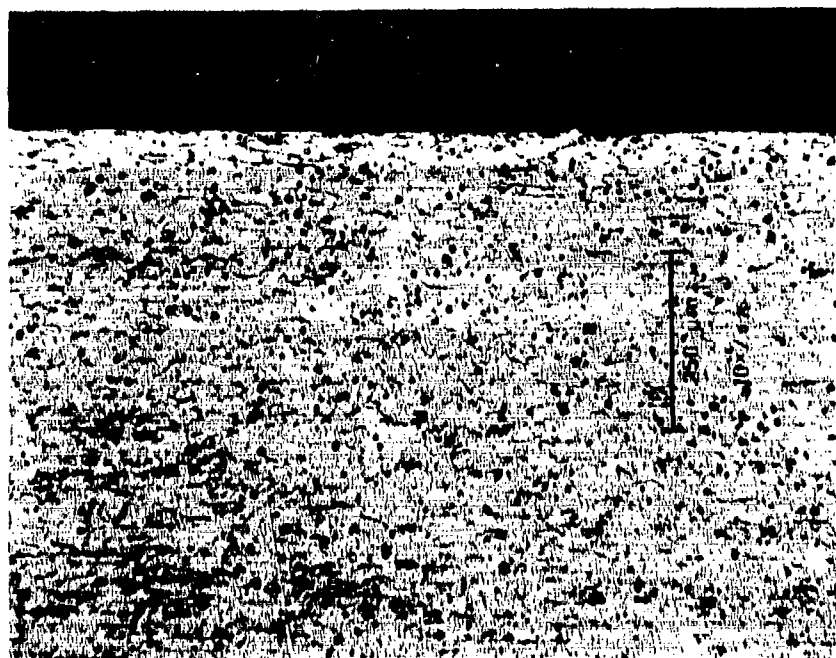
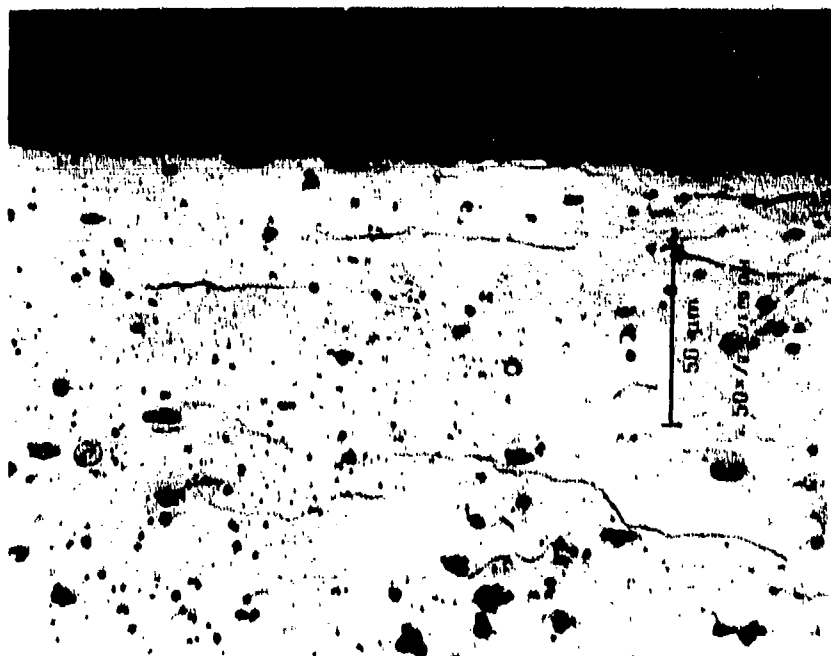
Metallographic analysis indicated that plastic bead paint removal damaged the surface of the sulfuric acid anodized 7075-T6 for either nozzle pressure (Figures 16-18). Some surface pits were detected which measured approximately 0.5 mils across and 0.08 mils deep (Figure 17). Since the unclad 7075-T6 is substantially harder than the alclad 7075-T6 surface, the unclad 7075-T6 was less susceptible to damage by plastic bead paint removal. If anything, it is believed that plastic bead blasting might improve the fatigue properties by peening, thus creating residual

Figure 17. Sulfuric Acid Anodized 7075-T6 Blasted with a Nozzle Pressure of 38 psi.  
MAG: (a) 100X, (b) 500X
